# ECUFPA

## Eastern Cape Vulture Fires 2016

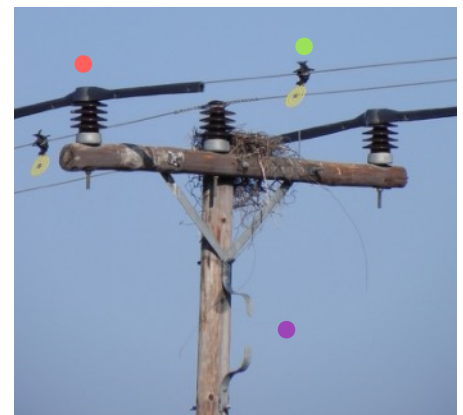
### Mitigated Structures

*The above image shows an old T-Structure that has been mitigated through installing **raptor protectors**, **bird flappers** and a **gapped earth wire**.*
